# International Association of Machinists & Aerospace Workers

August 13, 1991

During the disassembly of the rudder hydraulic power unit taken from Flight 585 the primary control slide was found jammed in the secondary control slide on the rudder hydraulic power unit control servo (1PC27-00-XX-017H and 27-00-XX-017F included). The primary slide takes input from the yaw damper through the transfer valve and converts it to rudder movement. The secondary slide takes rudder pedal mechanical movement and converts it to rudder movement. The primary slide moves inside the secondary slide and the secondary slide moves inside the servo body. At no time should there be metal-to-metal contact between the slides or servo body.

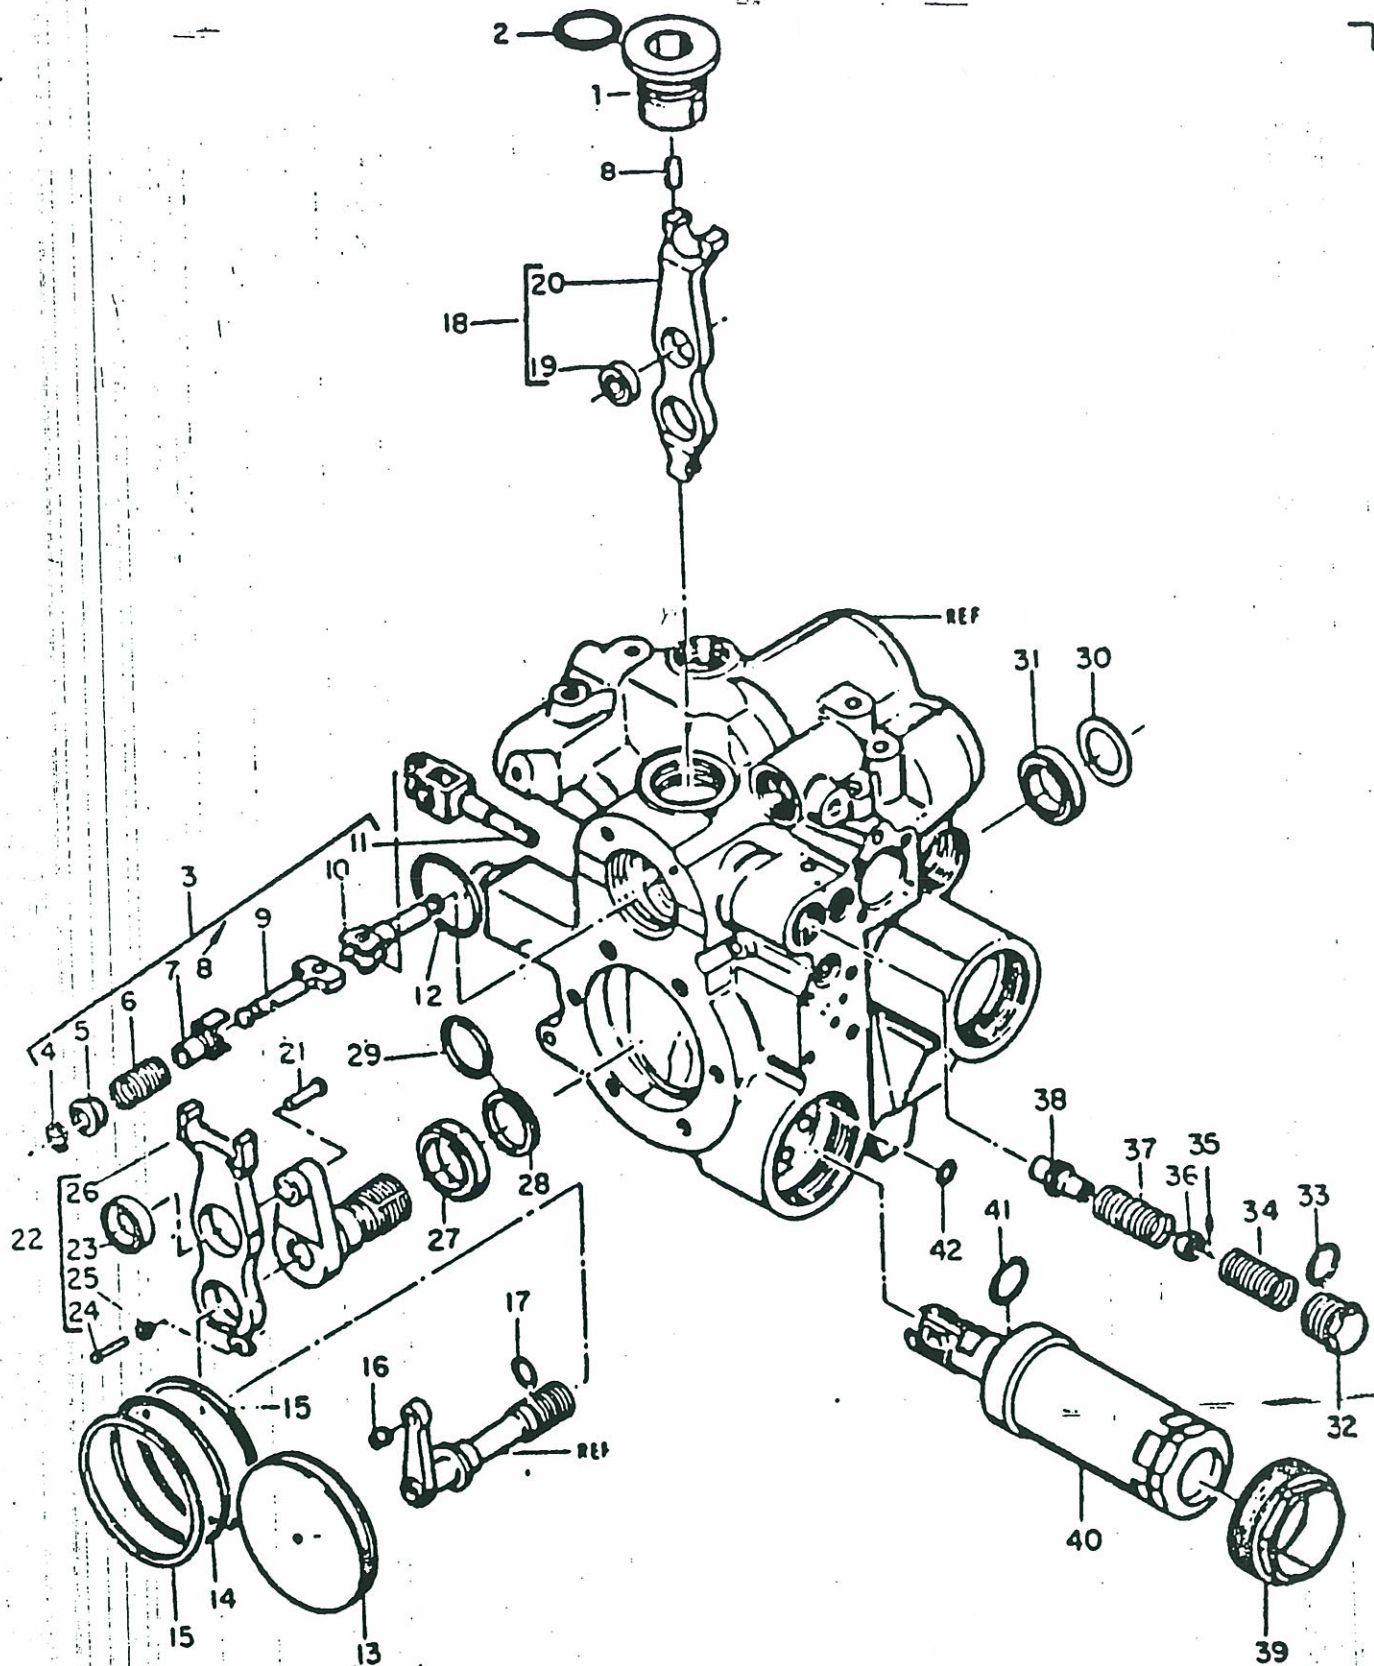
VALVE ASSY-CUAL SERVO

Examination of the control servo disclosed that the tapered end, which connects to the control arm input, was stuck on the flat surface of the secondary slide. After forcing the primary slide off the flat surface of the secondary slide, the primary slide operated normally inside the secondary slide.
